TECH NOTE

No. 210-T02

Smoking Rivets Can Be Detrimental To Your 210

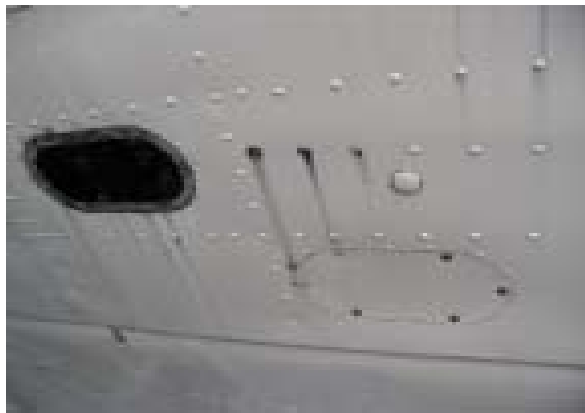
"Smoking Rivets"

For those of us who either own or work on the cantilever winged 210s, the issue of 'smoking rivets' on the lower inboard spar is becoming an ever more prevalent problem. While the first signs of dark streamers do not pose an immediate danger, the longer one waits to take action the greater potential exists for a more expensive repair.

The smoking is caused by the metals working against each other eventually causing the rivet to move. This wearing generates a fine aluminum powder that is black in color giving the appearance of smoking as it streams away. Frequently, the first sign of smoking is noticed shortly after treatment with a corrosion inhibitor like Corrosion X. These penetrants work into the wear areas and flush the powder out causing unsightly streaking on the most visible portion of the airplane. One certain way to avoid this problem is to stop flying your plane. Keep reading if you would like a better option.

The remedy most certainly must include replacing the smoking rivets. FAA FAR 43 appendix-A, paragraph (b)(1)(iv), categorizes this as a major repair which must be performed by a certified airframe mechanic and subsequently signed off by an A&P with FAA Inspector Authorization. Also, the required FAA Form 337 must refer to approved data to support the repair method. Approved data can be in the form of an Airworthiness Directive,
