TECH NOTE

No. 210-T02

Smoking Rivets Can Be Detrimental To Your 210

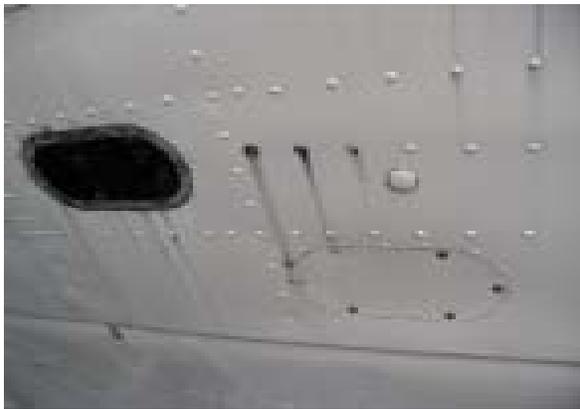
For those of us who either own or work on the cantilever winged 210s, the issue of 'smoking rivets' on the lower inboard spar is becoming an ever more prevalent problem. While the first signs of dark streamers do not pose an immediate danger, the longer one waits to take action the greater potential exists for a more expensive repair.

The smoking is caused by the metals working against each other eventually causing the rivet to move. This wearing generates a fine aluminum powder that is black in color giving the appearance of smoking as it streams away. Frequently, the first sign of smoking is noticed shortly after treatment with a corrosion inhibitor like Corrosion X. These penetrants work into the wear areas and flush the powder out causing unsightly streaking on the most visible portion of the airplane. One certain way to avoid this problem is to stop flying your plane. Keep reading if you would like a better option.

"Smoking Rivets"

The remedy most certainly must include replacing the smoking rivets. FAA FAR 43 appendix-A, paragraph-(b)(1)(iv), categorizes this as a major repair which must be performed by a certified airframe mechanic and subsequently signed off by an A&P with FAA Inspector Authorization. Also, the required FAA Form 337 must refer to approved data to support the repair method. Approved data can be in the form of an Airworthiness Directive,

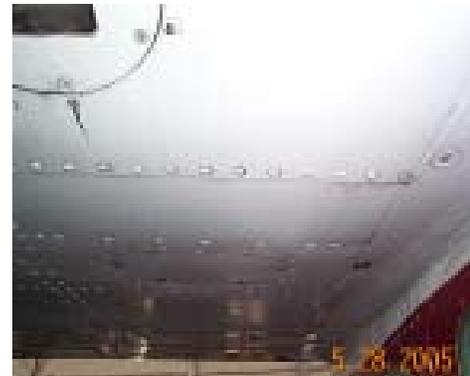
210 Universal Spar Rivets

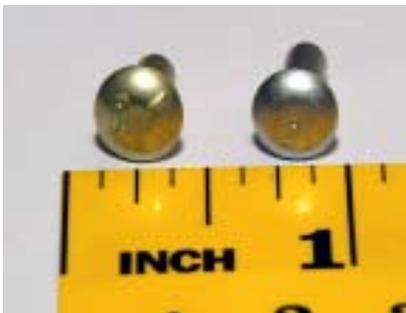
The 1985-86 Cessna 210 series service manual structures section paragraph 18-65 specifies acceptable replacement rivets. The substitute rivets listed are of the blind type, which we do not want to use. The DD rivets are not specifically listed as acceptable but are also not

Rivet Heads

prohibited, therefore FAA AC 43.13-1B can be used as 'approved' data for replacement of standard hardware. Section 4, chapter 4, paragraph 4-57b and 4-57d of the same advisory allows the use of any standard solid rivet of equal or greater strength whose material has no dissimilar metal concerns. More information on DD rivets can be found in several other books, including aircraft structural textbooks and Military Handbook 5.

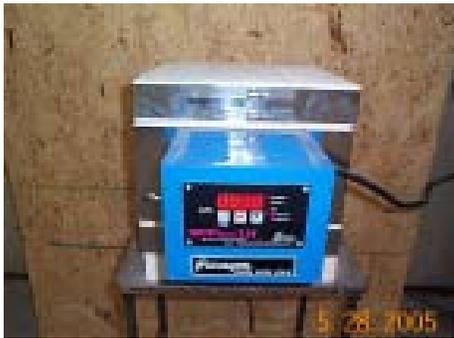
At this point you will need a kiln capable of holding 870 degrees Fahrenheit, plus or minus 10 degrees for about an hour. The ideal temp is 930 but the slightest over temp causes the rivets to be too brittle to set, so 870 was chosen to give good cushion. We did a search on the Internet, and for less than five hundred dollars, purchased the smallest good quality kiln with a digital temperature control that we could find. The kiln can be small because we are only 'cooking' a hand full of rivets and the digital control is needed to accurately maintain the temperature within the limits. Place twice as many rivets as you need into the kiln basket because rivets are cheap in comparison to time spent firing the kiln up a second time for just one more rivet. Set the kiln to ramp up to the required 870 degrees slow enough to not over shoot the temp and melt the rivets. After they have been at 870 degrees for about one hour, quickly remove the basket and dip it in cool water to quench the rivets. With the first group of rivets that we heated and then quenched, we expected a lot of steam and boiling but it was very anticlimactic. You have approximately thirty minutes before the rivet begins to harden, but if you have a delay in your

Rivet Kiln

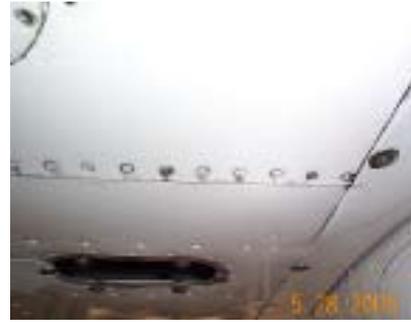
Flush Spar Rivets

their maximum strength in approximately one hour and full strength four days after setting. Be sure and wait the required four days or you will be doing it all again soon. A little touch up paint on the new rivet heads and you are ready to go.
